Cooling Tower & Chiller Plant Case Studies

The Benefits of HydroFLOW

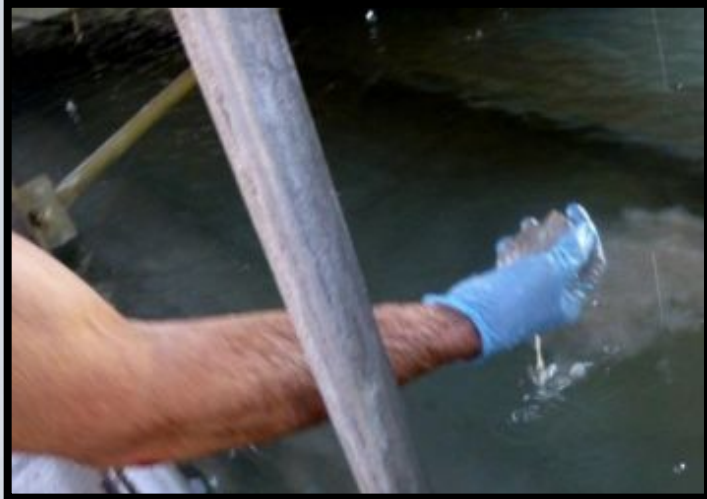
As minerals precipitates out of solution as fine powder, they can be filtered out, saving bleed/blow-down .water consumption

Loose mineral deposits collected in the sump, instead of inside pipes and equipment as hard .scale

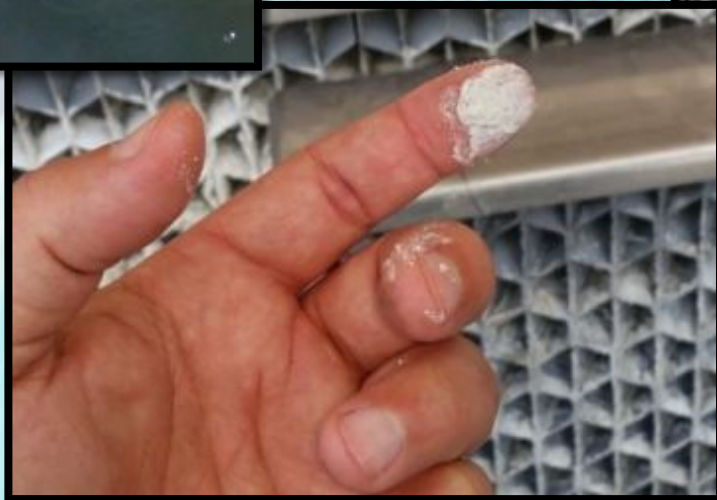
.Drift eliminator before

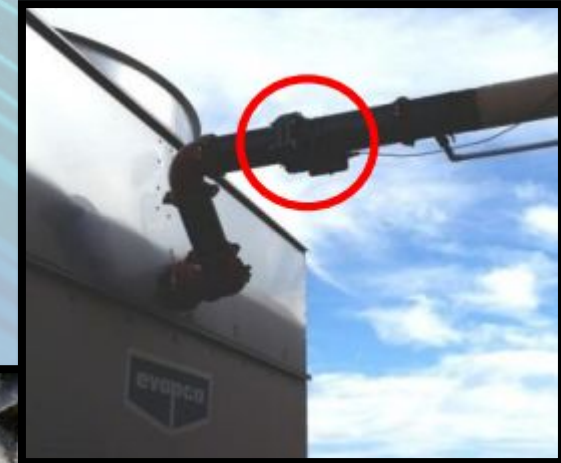
Installed *HydroFLOW* .device

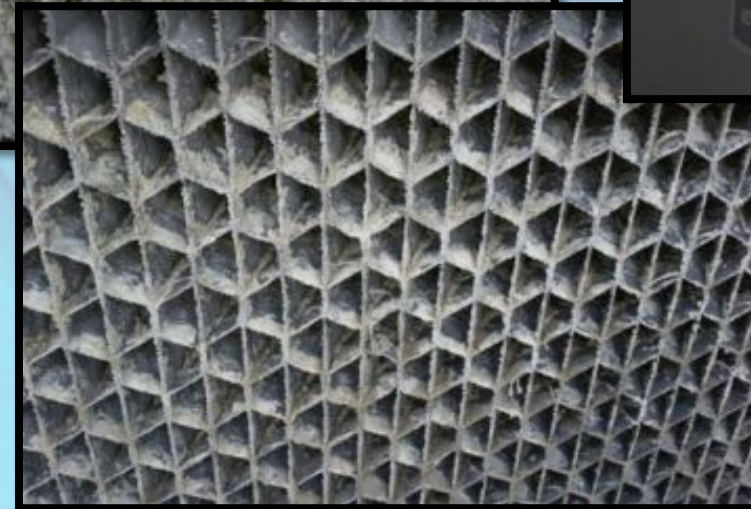
.Drift eliminator after

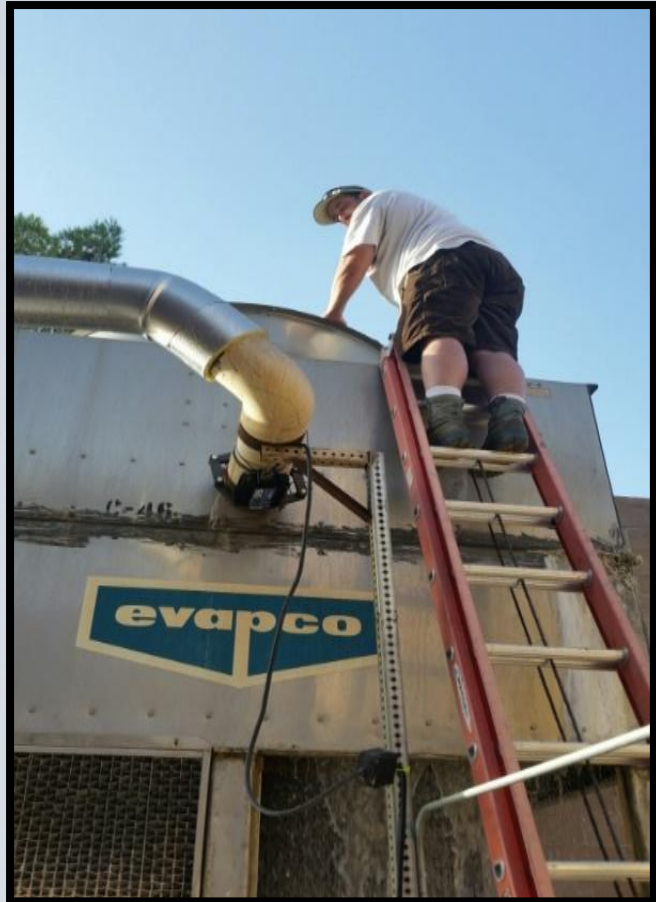
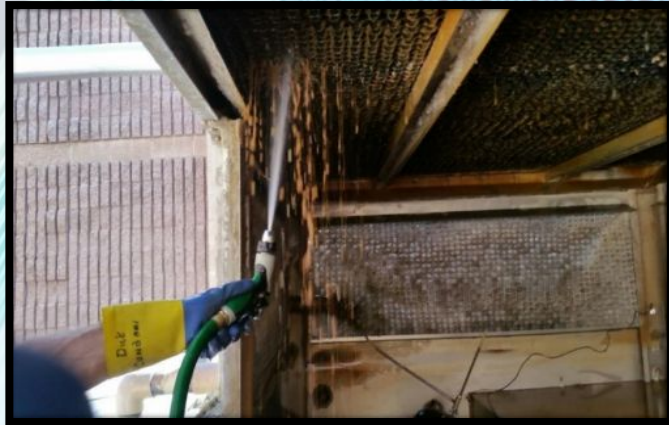
Instead of the hard scale that typically accumulates inside the cooling tower, loose brown mud-like material was found. A garden hose was used to easily remove the mud-like substance from the fill material and the drift eliminators.
