Third-Party Technology Verification of the Hydropath Technology at the Robert W. Hite Treatment Facility, Denver, Colorado

PREPARED FOR: Tal Journo/*HydroFLOW* USA LLC (*HydroFLOW* USA)
PREPARED BY: Samuel Jeyanayagam, PhD, PE, WEF Fellow/CH2M HILL, Inc. (CH2M)
DATE: 27 September 2017

This technical memorandum specifically discusses the verification testing completed at the Robert W. Hite Treatment Facility (RWHTF) in Denver, Colorado, and the observed outcome.

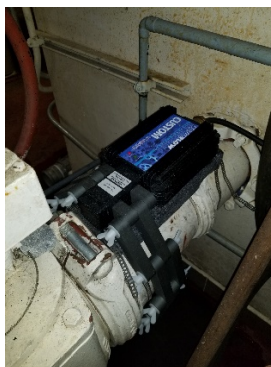
Figure 1. Typical *HydroFLOW* Unit Installation

The *HydroFLOW* I Range uses Hydropath technology. When properly installed on a pipe (see Figure 1), it induces a 150 kilohertz, oscillating sine wave, alternating current (AC) signal. The electric induction is performed by a special transducer connected to a ring of ferrites. The pipe and the flowing fluid act as a conduit, which allows the signal to propagate. The induced AC signal is believed to cause the mineral ions that make up struvite (magnesium, ammonium, and phosphate) to form loosely held together clusters. When certain conditions are created (e.g., pressure change, temperature change, and turbulence) the clusters precipitate out of solution and form stable crystals of struvite that remain in suspension and are not able to adhere to surfaces as hard scale; the crystals are carried away with the flow. Because hard scale no longer accumulates, the shear forces created by the flowing liquid erode and soften existing scale deposits over time. It is important to note that constant liquid flow is required to remove hard scale deposits from a system.

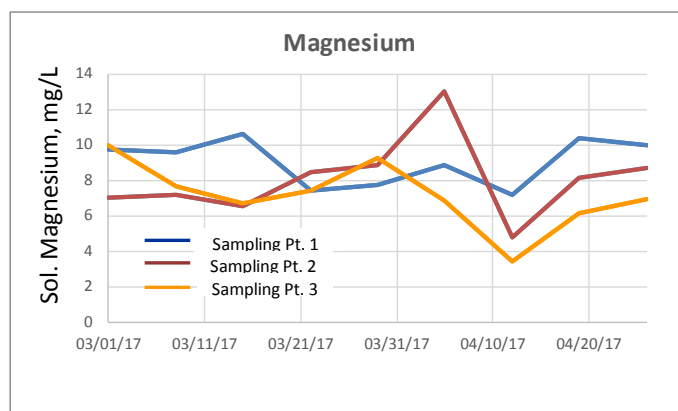
Figure 4. Soluble Magnesium Concentration Profile

A good indication of struvite formation is the change in soluble concentrations of its key constituents: magnesium, ammonium, and phosphate (ortho-phosphate). As shown on Figures 4, 5, and 6, these parameters did not exhibit any appreciable change between Sampling Points 1 and 3 during the sampling period (1 March through 26 April 2017), which implies there was no struvite formation or scaling.

A review of the average values over the sampling period (see Table 3) shows that although concentrations and pH were favorable for struvite formation, this did not occur and the concentration profiles of the three soluble components remained relatively flat at the three sampling points. If struvite formation had occurred in the test segment, soluble concentrations would have declined between Sampling Points 1 and 3.

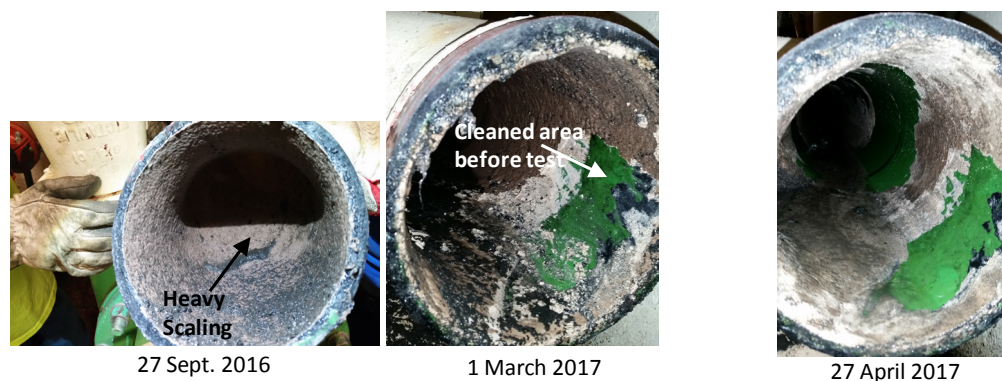
Figure 8. Before and After Photographs of the Transfer Pump Discharge Pipe

The before and after photographs of the pump discharge pipe between the transfer pump and second *HydroFLOW* unit are shown on Figure 8. The “before” photograph dated 27 Sept 2016 shows heavy scaling and reduced pipe inside diameter. The photograph dated 1 March 2017, before the test, shows the section of hard struvite that was cleaned to exposed the green, glass-lined pipe. The “after” photograph, dated 27 April 2017 shows the following:

- The clean section of the pipe remained clean, with no new struvite deposition.
- Some of the hard struvite had been gradually removed to further expose the pipe.
- The remaining struvite scale had become softer and thinner.

- Before the test, the scale was thick (approximately 1/8 inch), hard, and greyish in color. It was possible to collect large pieces of hard scale.
- Sixty days into the test, the scale was softer and thinner, with some areas of the surface becoming visible. The scale samples broke into smaller pieces.
- At the end of the test, the scale was significantly thinner, making it impossible to collect a scale sample. An increasing amount of surface was exposed.

This technical memorandum verifies that the use of *HydroFLOW* I Range units at the RWHTF prevented scale formation in the centrate transfer pump and pipe. The *HydroFLOW* units also caused changes in the characteristics of the existing scale, making it easy to be removed by the flowing liquid. It should be noted that following the test, RWHTF purchased and installed four *HydroFLOW* units on the centrate and digested sludge lines.
