HydroFLOW Cooling Tower Inspection Report

Nellis Air Force Base

Updated on June 26, 2019

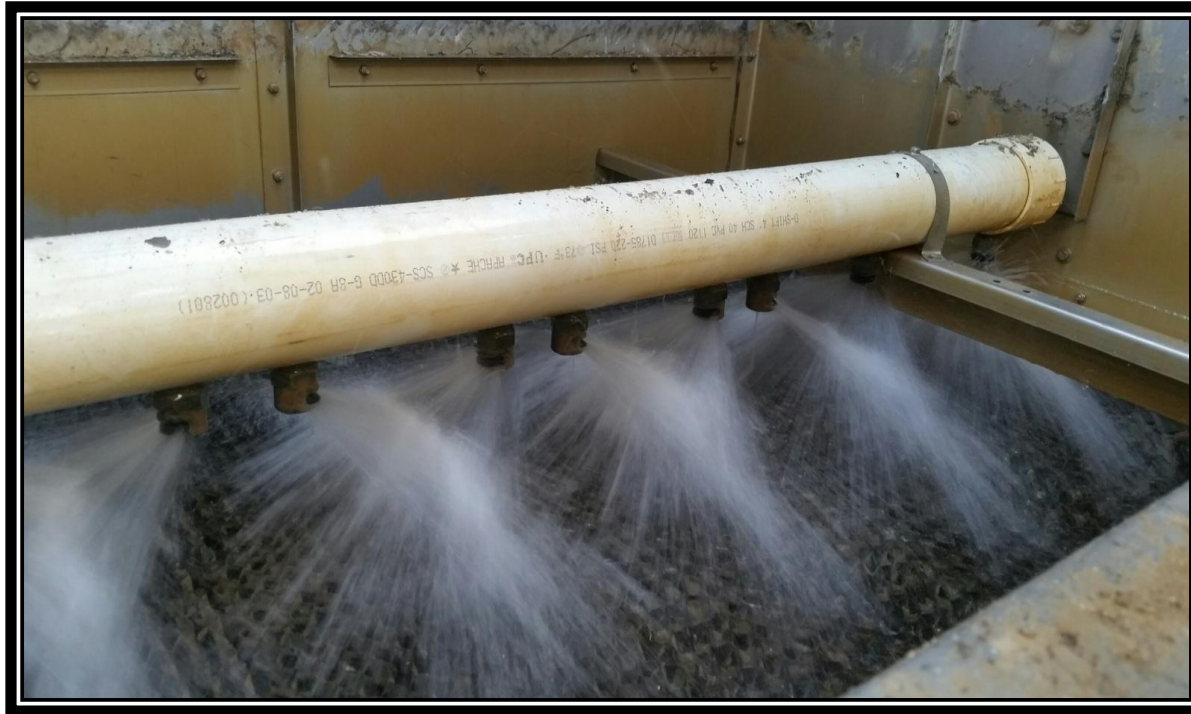
Due to equipment malfunction, the cooling tower's conductivity meter read 14,000 μ S, which was 6 times too high. Airman Payne repaired the damaged system and reset the controller back to the normal operational parameters of 2,300 μ S. No significant hard scale or bio buildup was observed on the nozzles or infrastructure.

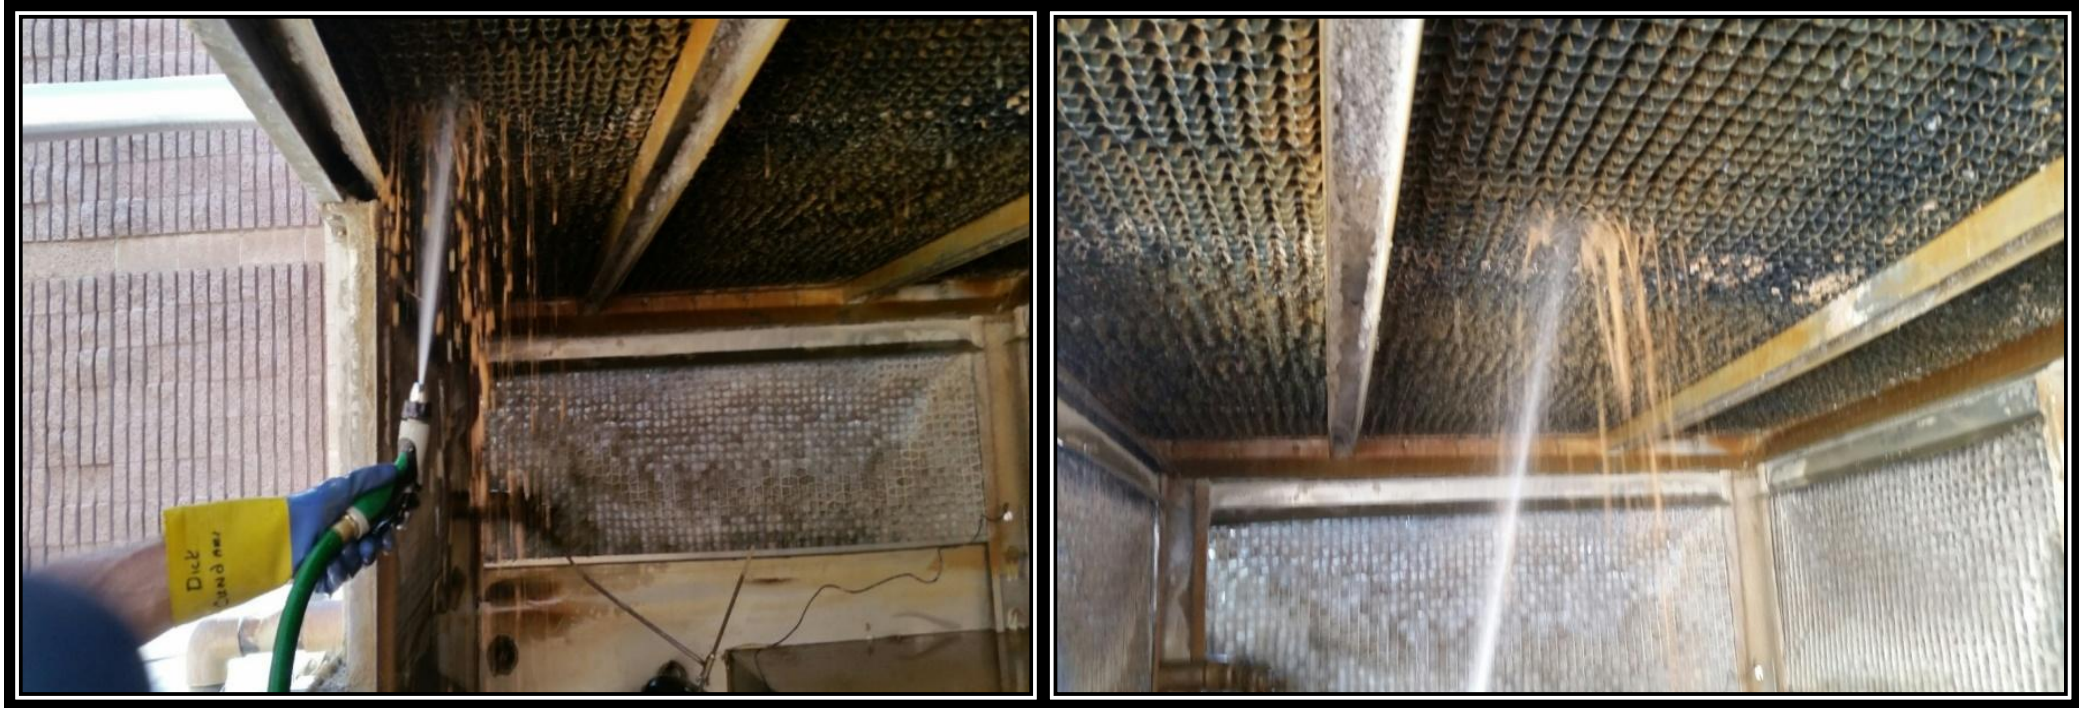
Instead of the hard scale that typically accumulates inside the cooling tower, loose brown mud-like material was found. A garden hose was used to easily remove the mud-like substance from the fill material and the drift eliminators.

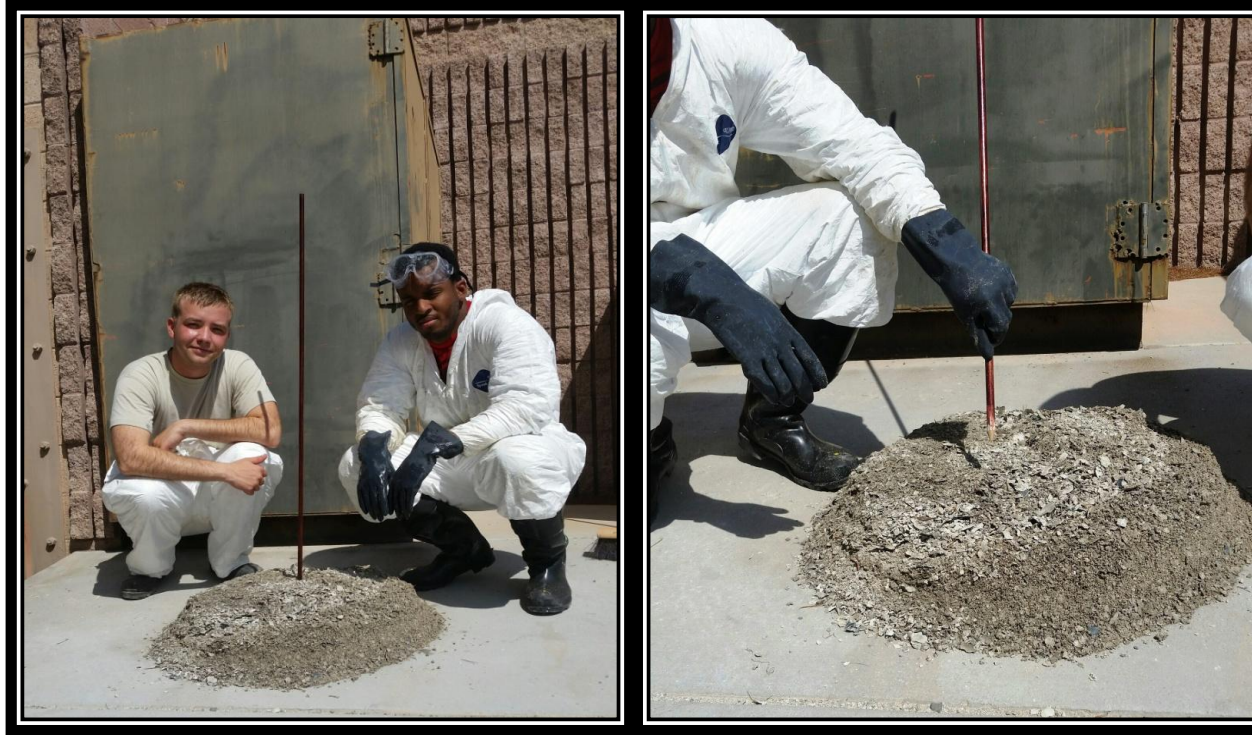
Senior Airman Buchanan and Airman Payne pictured next to the scale that was removed from the drift eliminators. The pile measured 30” in circumference at the base and 24” at the top, the depth was approximately 6”.

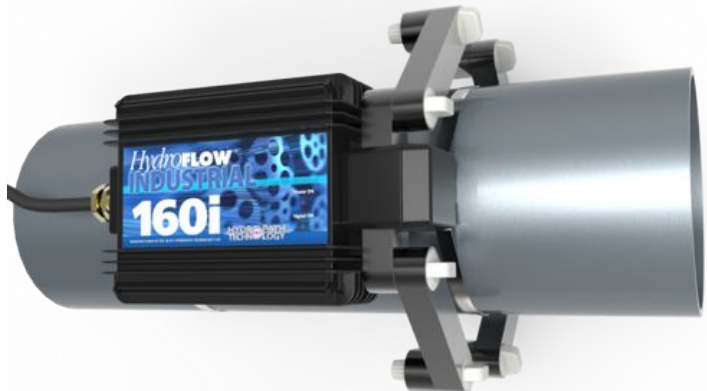
A *HydroFLOW* model 160i was installed on cooling tower 11. During the month of March 2019, a *HydroFLOW* representative inspected the cooling tower and 160i - both were in excellent operating condition. For additional information, please contact Randy Wood: 972-533-6225.
